### **Optimizer** offline

At the first point please do the following via fusiosnsolar web.

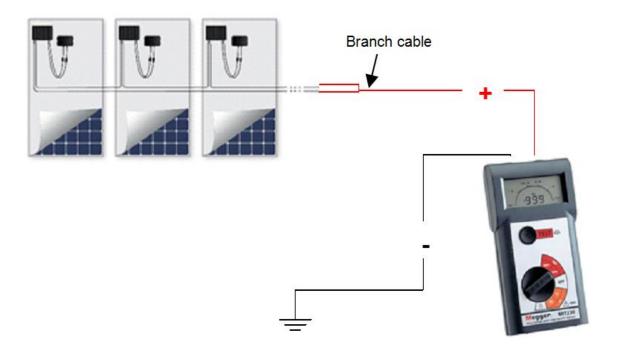
- 8) Measure the RISO on fully optimized strings (Take picture).
- Verify safe string voltage and current: max. 50V and 500mA.
- Connect the positive and negative connectors of the first or last optimizer in the string to the branch cable.
- Connect the positive probe of the insulation tester to the branch cable.
- Connect the negative probe of the insulation tester to a ground point.
- Select 500V testing on the insulation tester.
- Test the insulation.

If the resistance is less than  $600k\Omega$  in a single phase inverter or less than  $1M\Omega$  in a three phase inverter, continue checking this string's components to isolate the source of leakage. Always make sure to connect both negative and positive output connectors to the tester using a branch cable.
